Annexure A

Scope of work

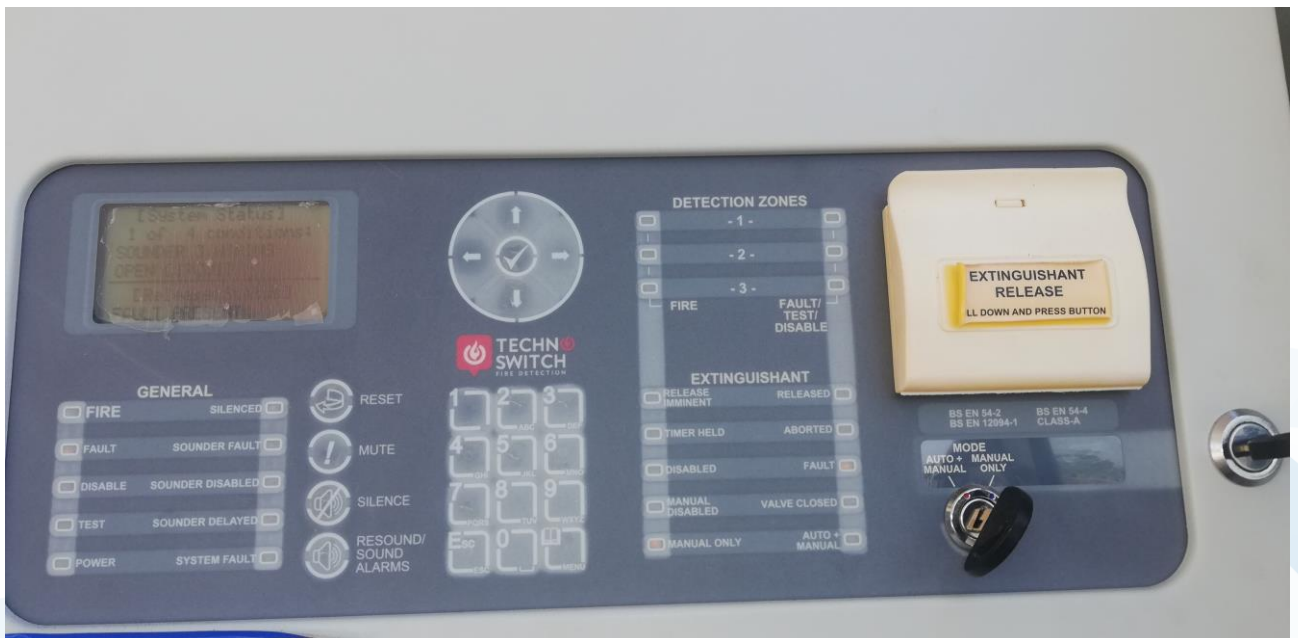
Current Extinguishing Combination Panel:

The current panel is outside the building and because of the Durban weather the panel has deteriorated hence the decision to move it inside the building.

- 3 x A45E-1 Interfaces faulty and requires replacement.
- Current Extinguishing Combination Panel faulty and requires replacement.
- The new panel must be moved to a new identified location inside the Equipment Room.
- Existing panel cabling, including 200VAC supply, requires to be decommissioned and extended to the new identified location which is about 20m away from the current location.
- A new weatherproof extinguishant remote display unit must be installed outside the room for information and mode switching purpose.
- Install communication system that will be linked to the fire system to send i.e. SMS to about 3/4 mobile numbers in case the alarm goes off.
- Testing & commissioning of the fire suppression and detection system.
